**Subject: Wetland Mapping and Affected Area-Habitat Assessment  
850 Rte. 28 Site  
Town of Kingston, NY**

## 850 Route 28 Property Wetland Narrative

## 850 Route 28 Property Disturbed Area Assessment

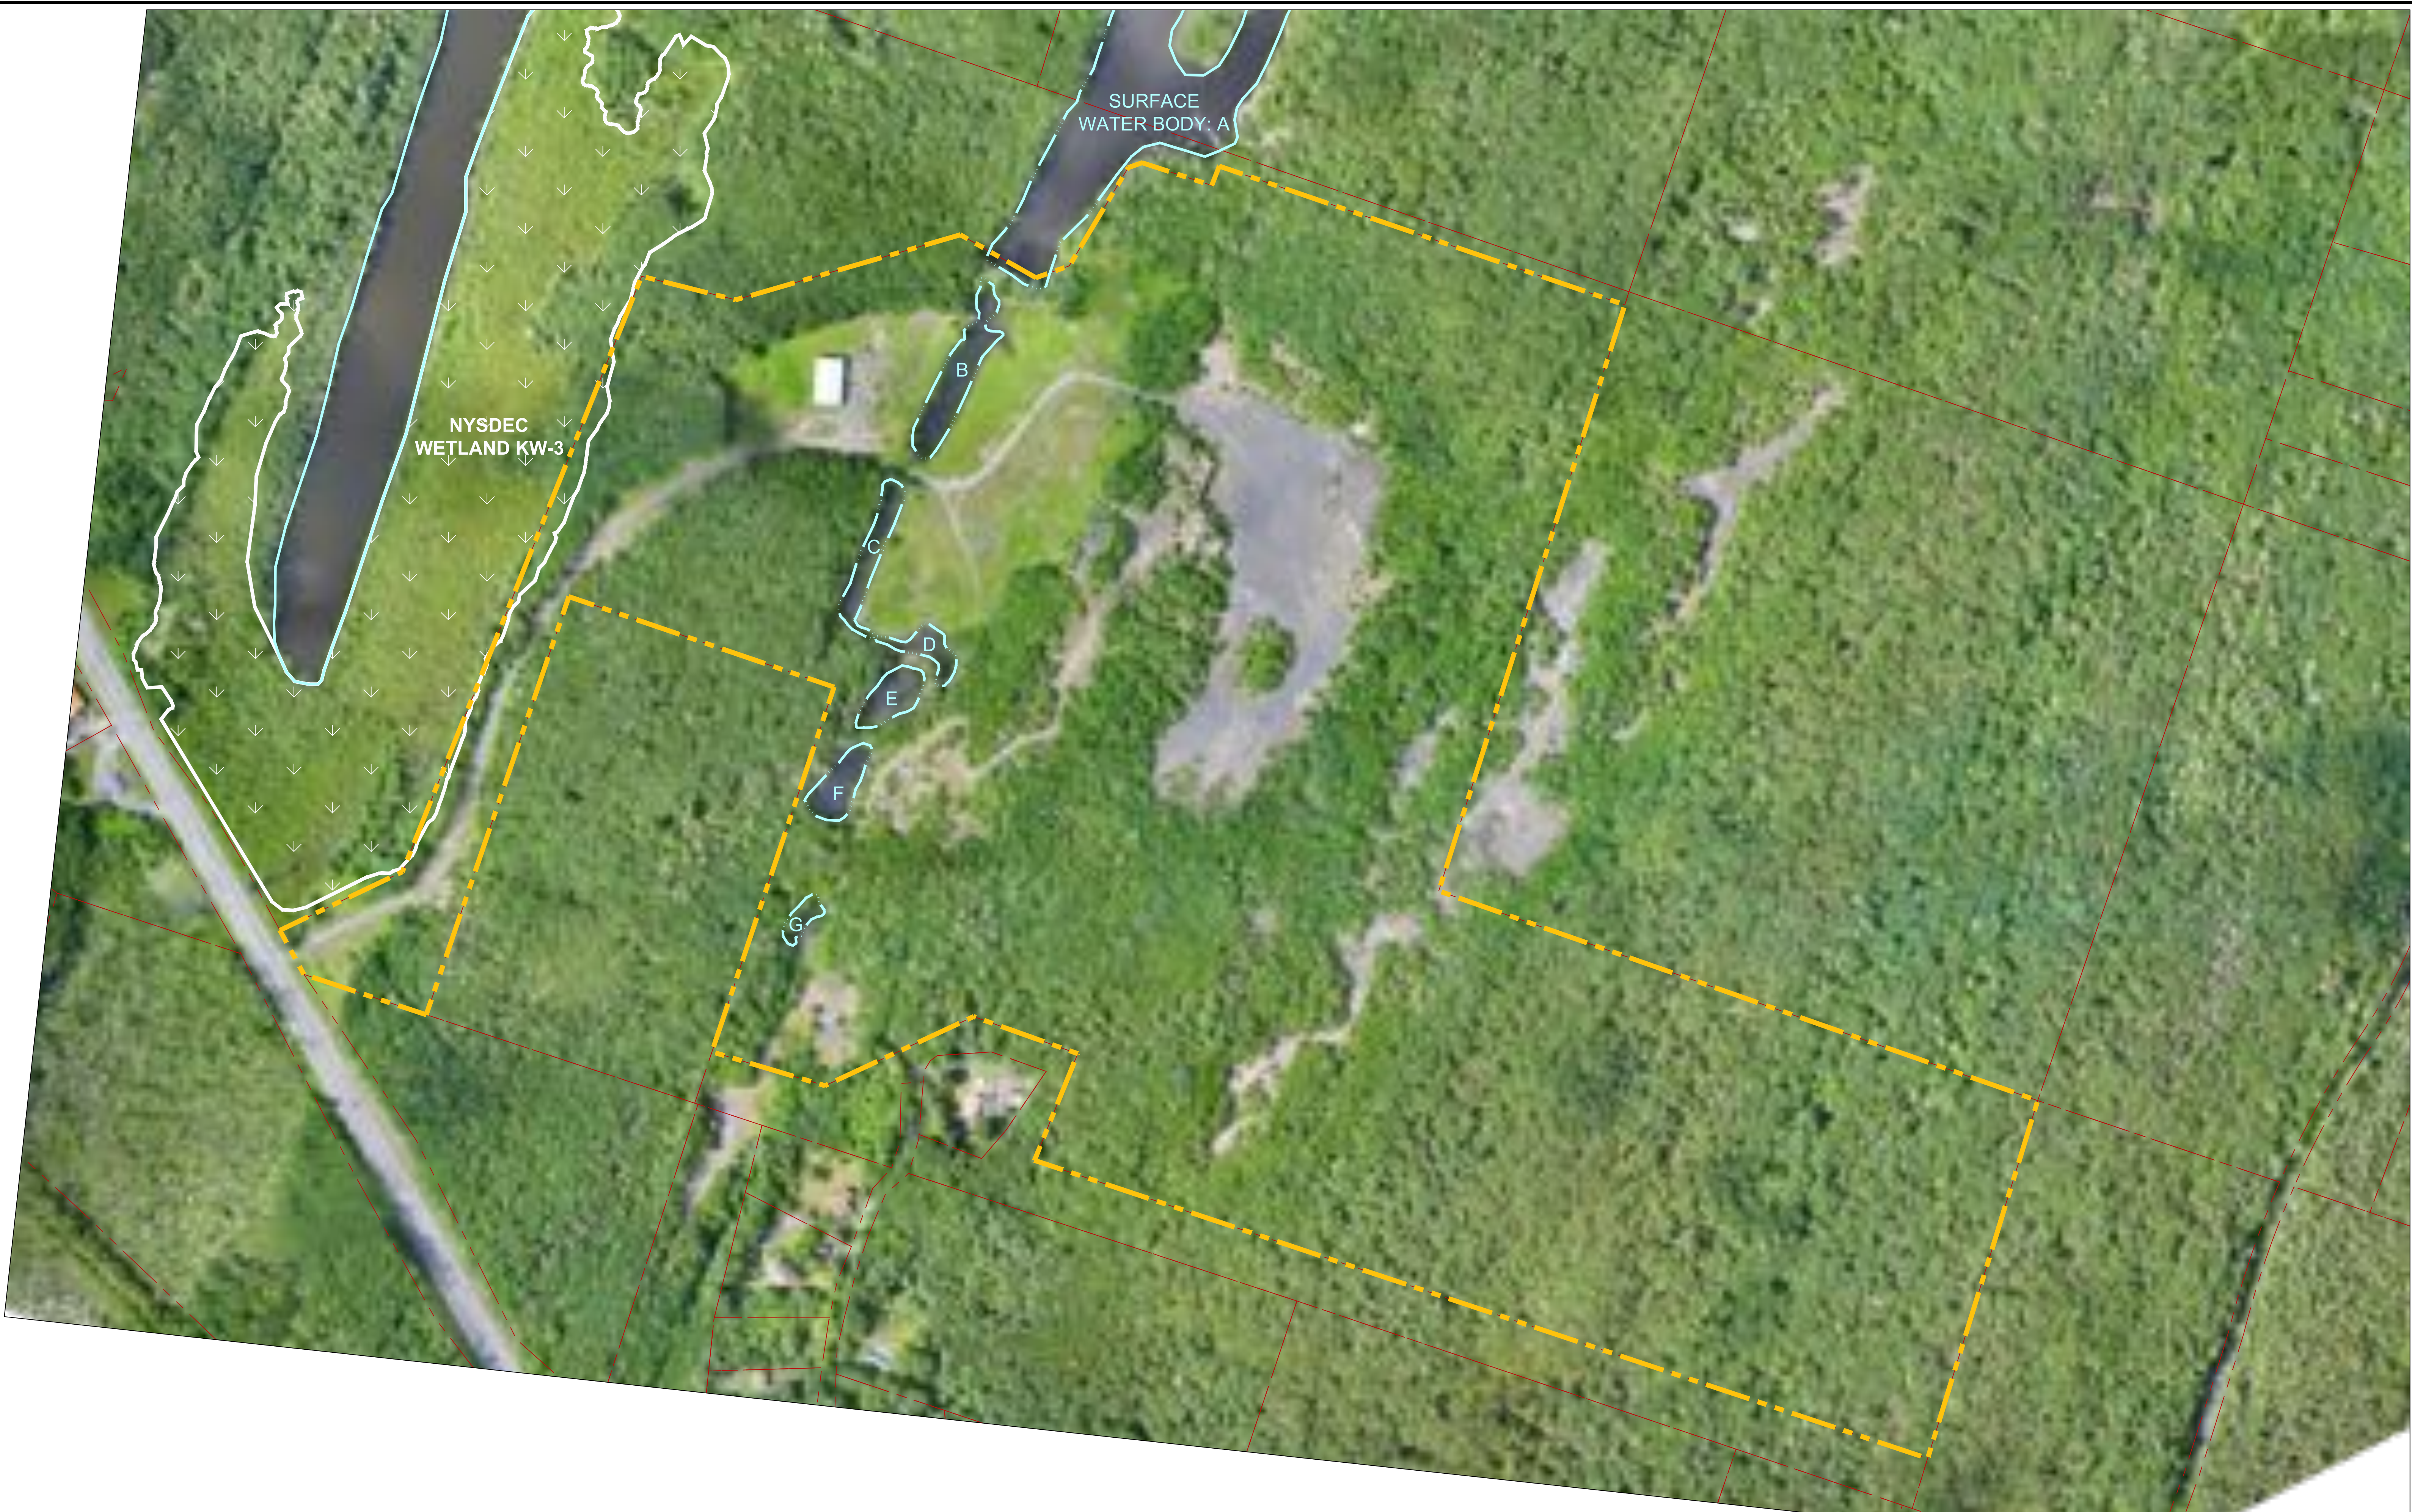
**FIGURE 1**  
SHEET 01 OF 01

For ease of identification the water bodies have been labeled alphabetically from north to south (Figure 1., see water bodies A-G) and are described below.

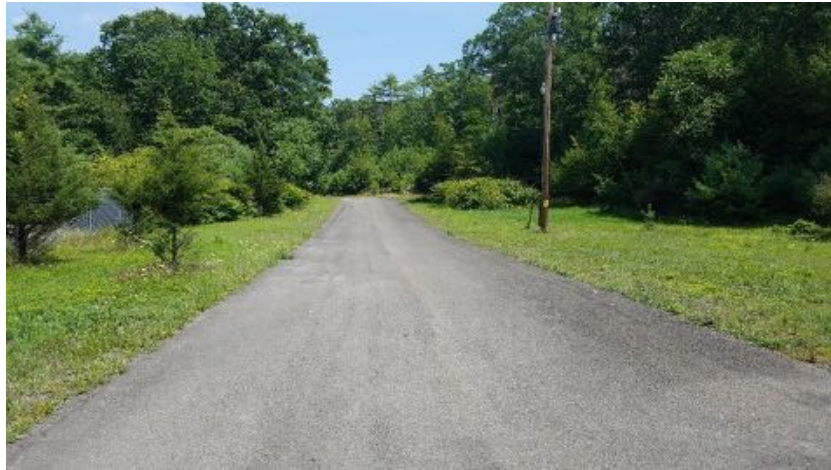
Photo 1. View of entrance road looking northeast.

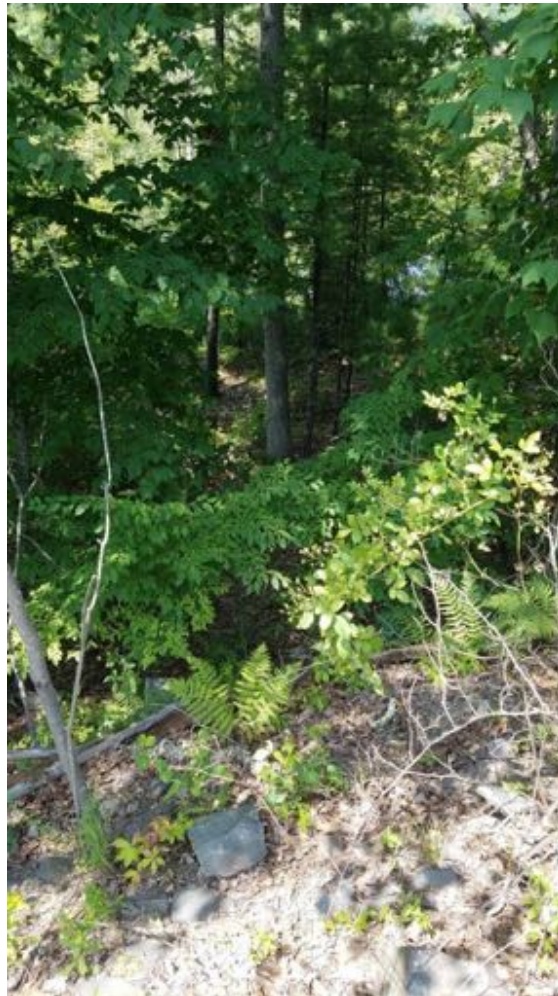
DEC Wetland KW-3 is mapped along the western perimeter of the Site. The purpose of the Site inspection was to approximate the limits of this wetland and or the wetland buffer area, should it exist as mapped along the entrance road to the Site. As mapped, the DEC wetland extends to the property line for approximately the first 1,000 of the access road starting from Route 28. The buffer area for the wetland parallels this limit and extends up to the garage currently located on the Site. Upon inspection of the Site topographic map and in conjunction with the Site visit, it is clear that wetlands associated with the DEC wetland exist in close proximity to the Site. In general, the area immediately west of the access road and for 25 feet, is either an upland area characterized by the shoulder of the road or a steep slope down to the adjacent wetland (Figure 1; Photo 1 and 2). The wetlands exist at the toe of the slope adjacent to the access road to the property and their lateral limits are more or less approximated by the 430 foot contour line as mapped by H2H (Figure 1). Given the steep slope down to the wetlands, the delineation of the upland and wetland boundary is relative sharp.

Photo 2. View to west of site entrance road shoulder, note steep slope and water body in top right of photo.

For planning purposes, it should be assumed that any improvements made to the road consider this wetland limit to the west and as appropriate all Site development should take into consideration the NYSDEC wetland buffer limitations where it occurs on Site.

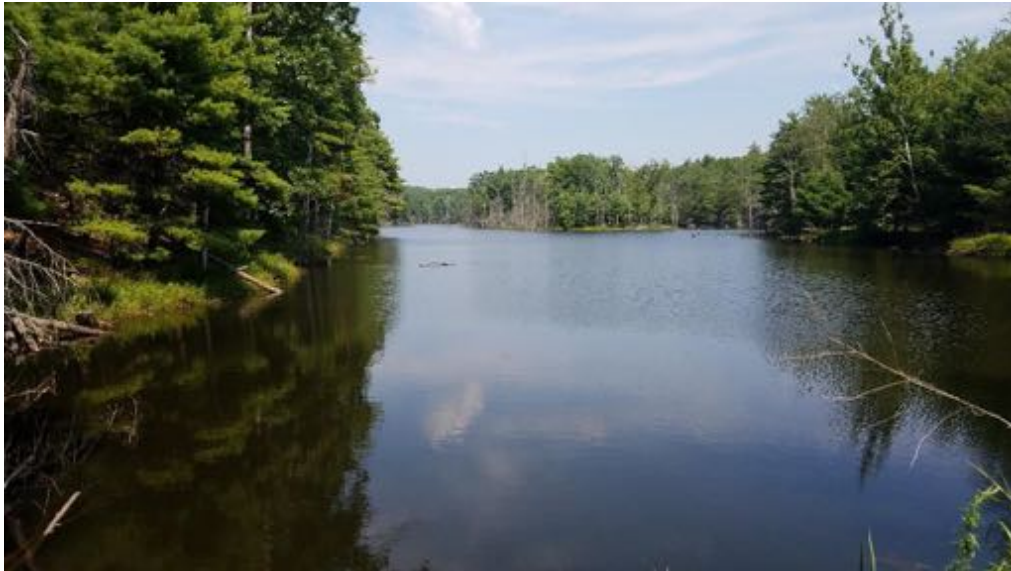
Waterbody A abuts the northern end of the property. This feature like the others is elongated north to south (Photo 3). At the southern end of this feature water drains from the north to south into waterbody B (Photo 4) via a small spill way at the western end of an earthen feature generally separating the two water bodies. This feature is not on the Site, but its connection to the Site is important to understand for future development potential.

Photo 3. View of Water Body A to north from embankment separating B and A.

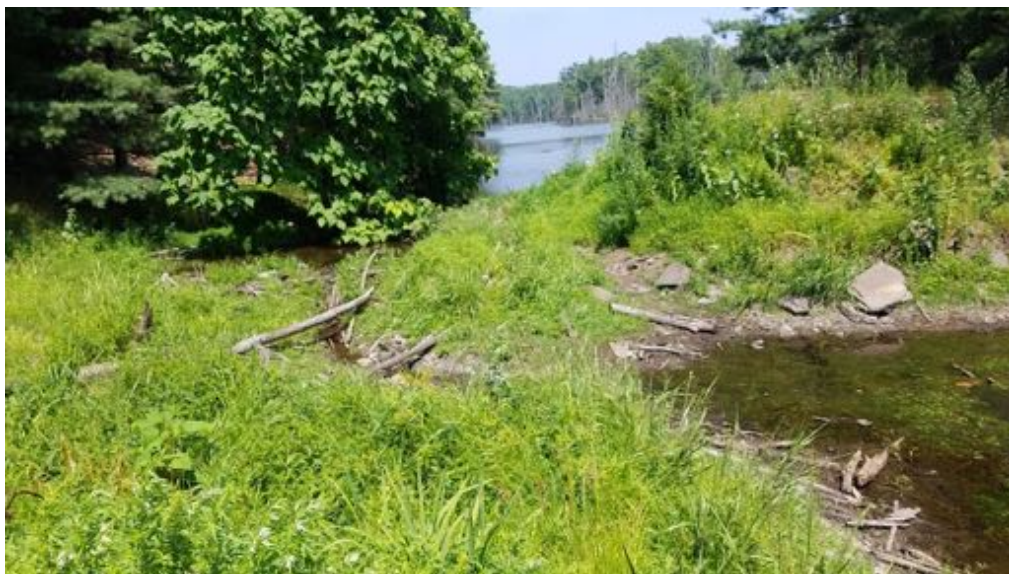
Photo 4. View looking north from Waterbody B to A, note hydrologic connection to left of photo through embankment material.

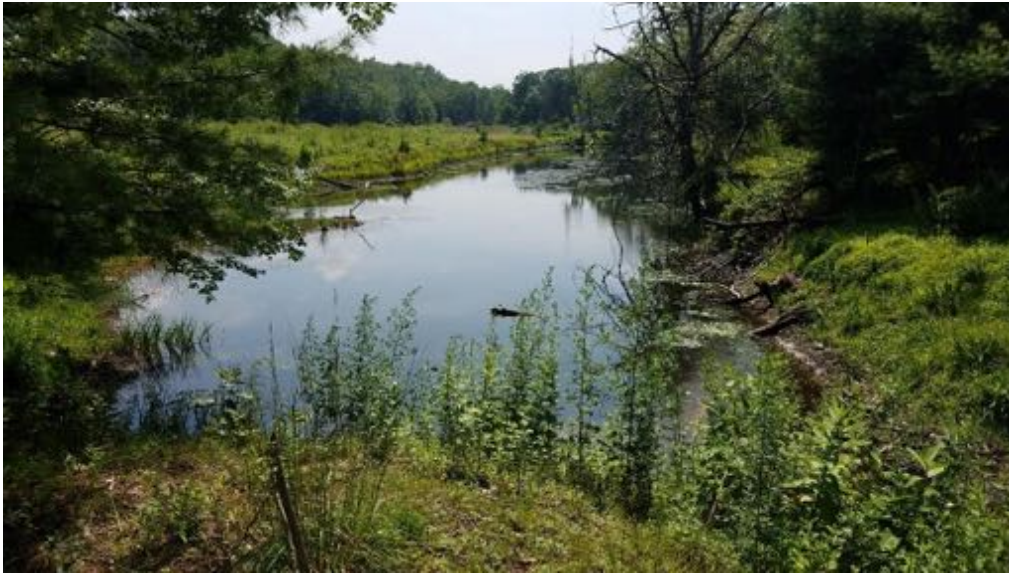
Waterbody B (Photo 5) is located immediately to the east of the garage and generally less a few feet deep. At the southern end of this feature is the existing Site access road that separates this water feature from Waterbody C to the south. There is no hydrologic connection, either man made or natural between features B and C (Photo 6).

Photograph 5. View of Waterbody B looking south from embankment separating A and B water bodies.

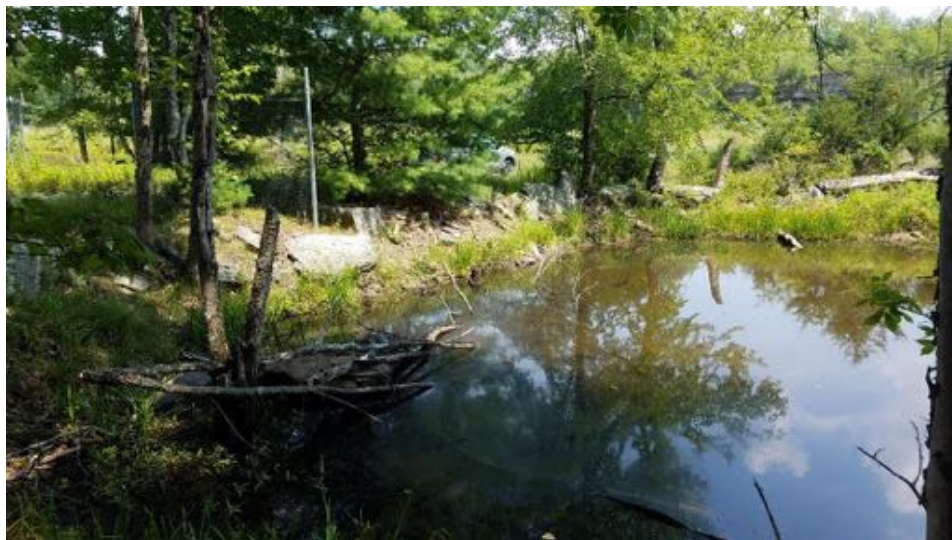
Photo 6. View of waterbody C looking north at embankment separating B and C water bodies.

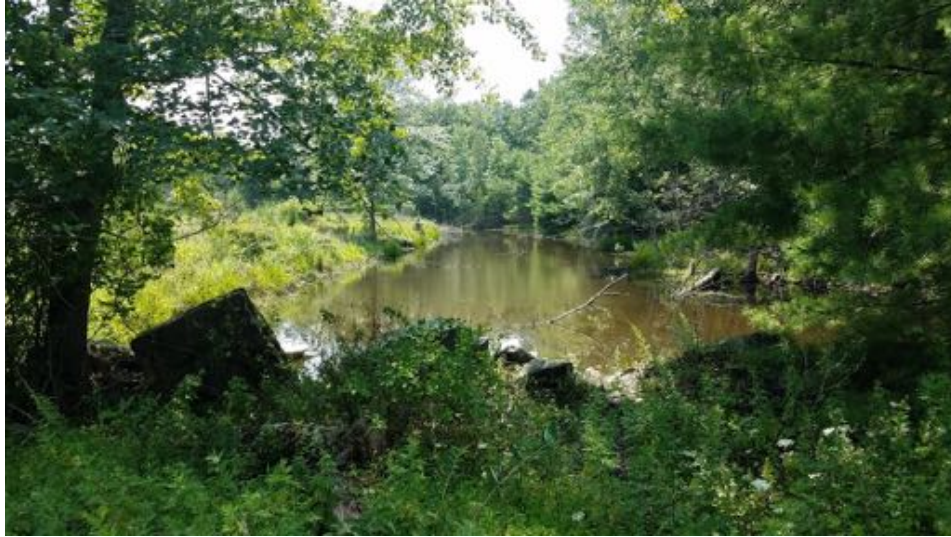
Waterbody C is located south of the access road and is hydrologically isolated from features B and C (Photo 7). There is no inlet to this feature. This feature is also bordered by bluestone spoil piles to the west and drains generally to the south towards features D and E. At certain pool elevations water will drain from C to feature D via a small drainage swale the exists through the land mass at the southern end of the feature (Photo 8).

Photo 7. View of Waterbody C looking south from entrance road.

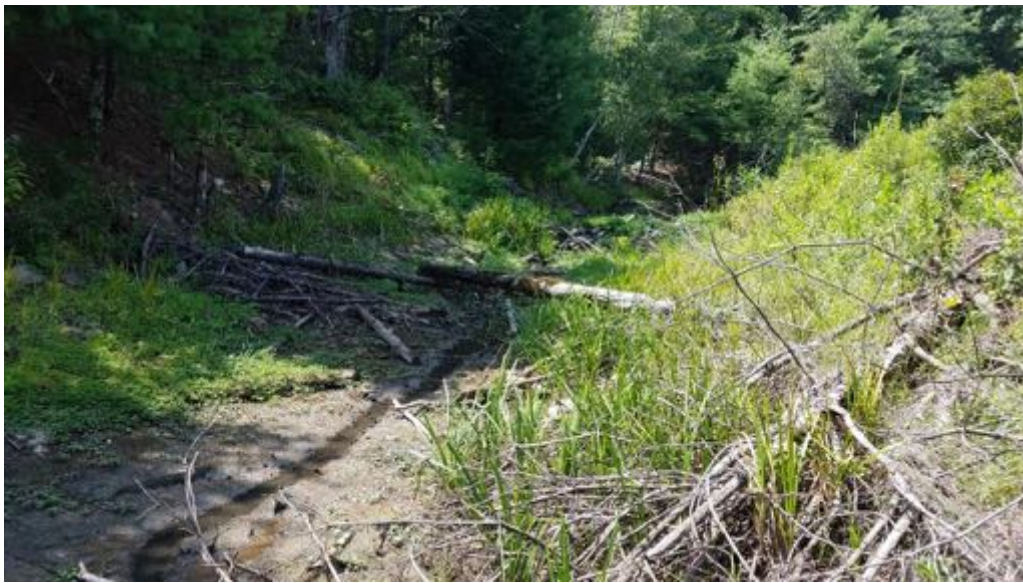
Photo 8. View looking west of hydrologic connection between Waterbody C and D.

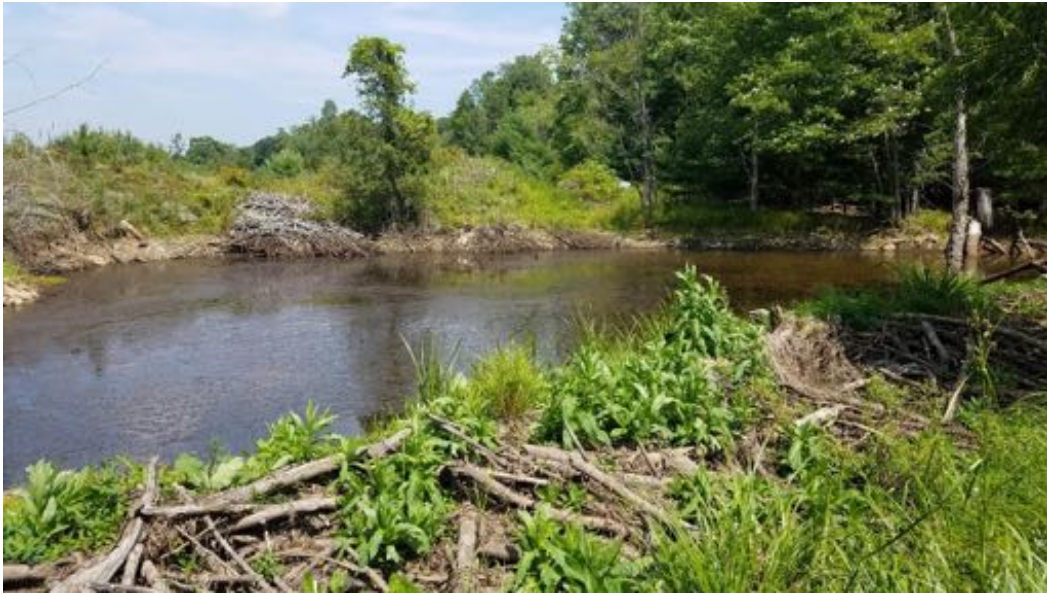
This feature is located south of feature C and is being created as a function of a beaver dam (Photo 9). The beaver dam appears to be inactive and there is no recent activity of beavers in the vicinity of this water feature. Large portions of this pool have water depths of less than a few inches.

Photo 9. View of water body D to north from beaver dam separating D from E.

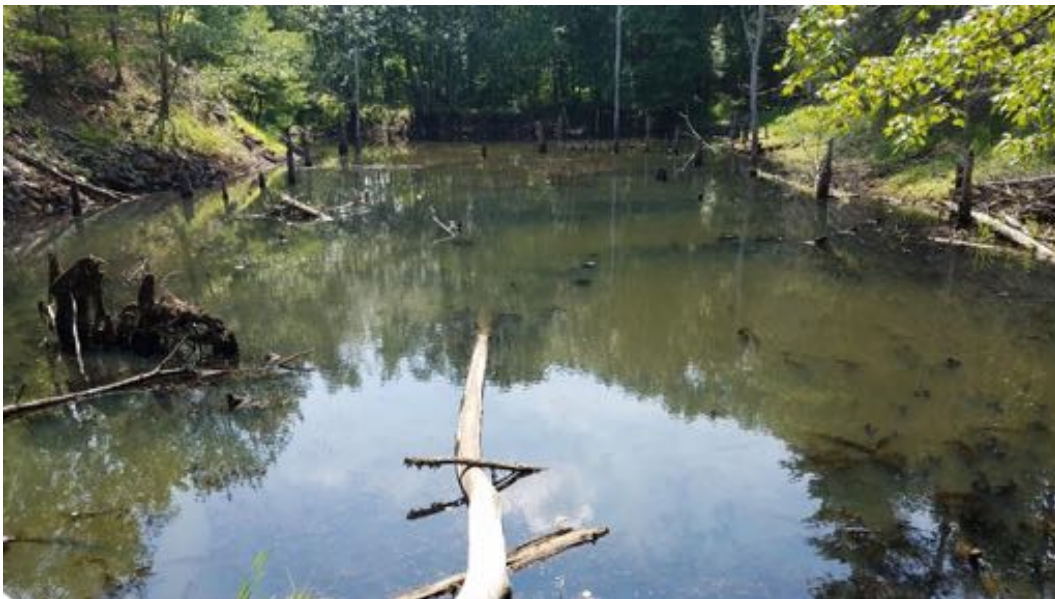
This feature is located south of feature D and is a result of historic mining activity on the site, like all other features (Photo 10). This feature is shallow and an earthen embankment is located at its southern end (Photo 11). Large portions of this pool have water depths of less than 1 foot. There is no outlet to this feature.

Photo 10. View looking south of water body E.

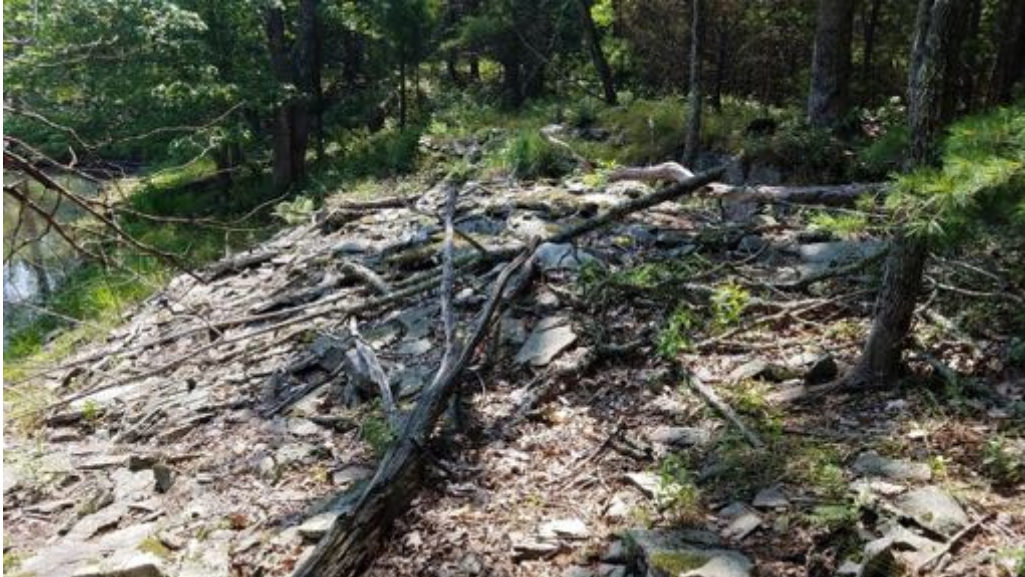
Photo 11. View looking west of embankment separating water bodies E and F.

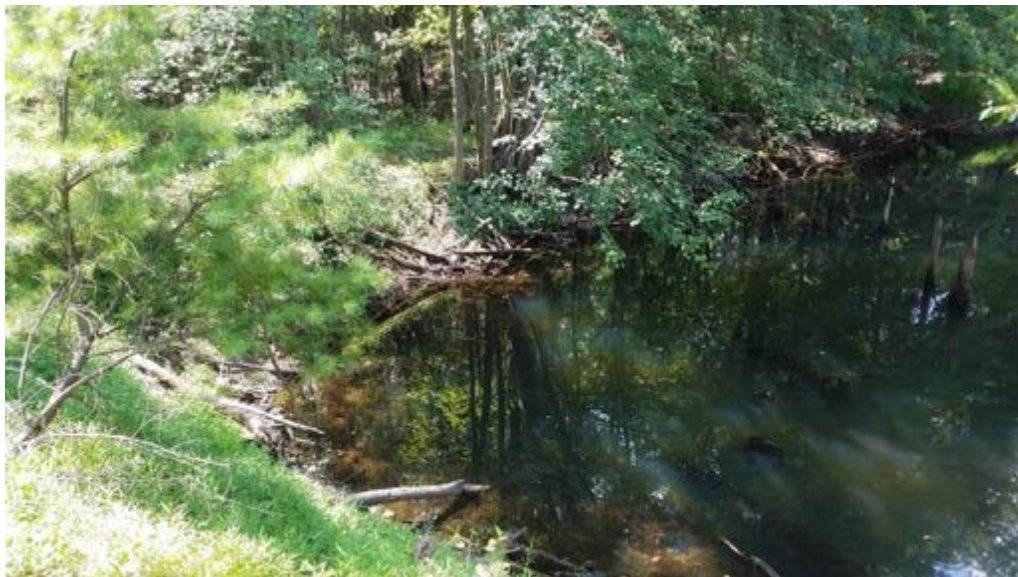
This feature is located south of feature E and is a result of historic mining activity on the site (Photo 12). This feature is shallow and an earthen embankment is located at its southern end (Photo 13). Large portions of this pool have water depths of less than 1 foot. There is no inlet and no outlet to this feature.

Photo 12. View of embankment and water body F.

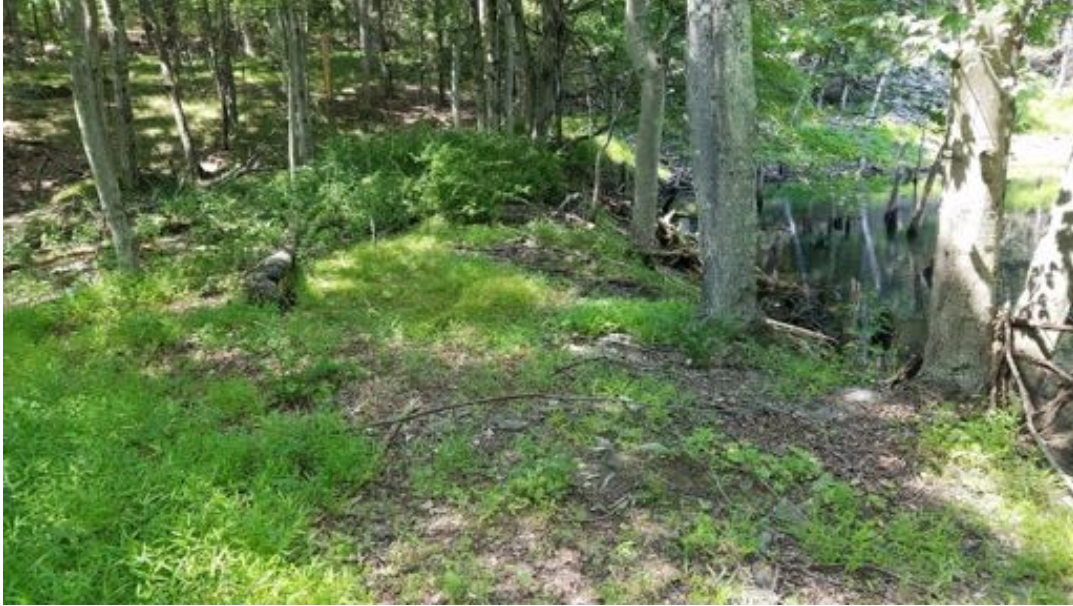
Photo 13. View of embankment looking west of along southern end of water body F.

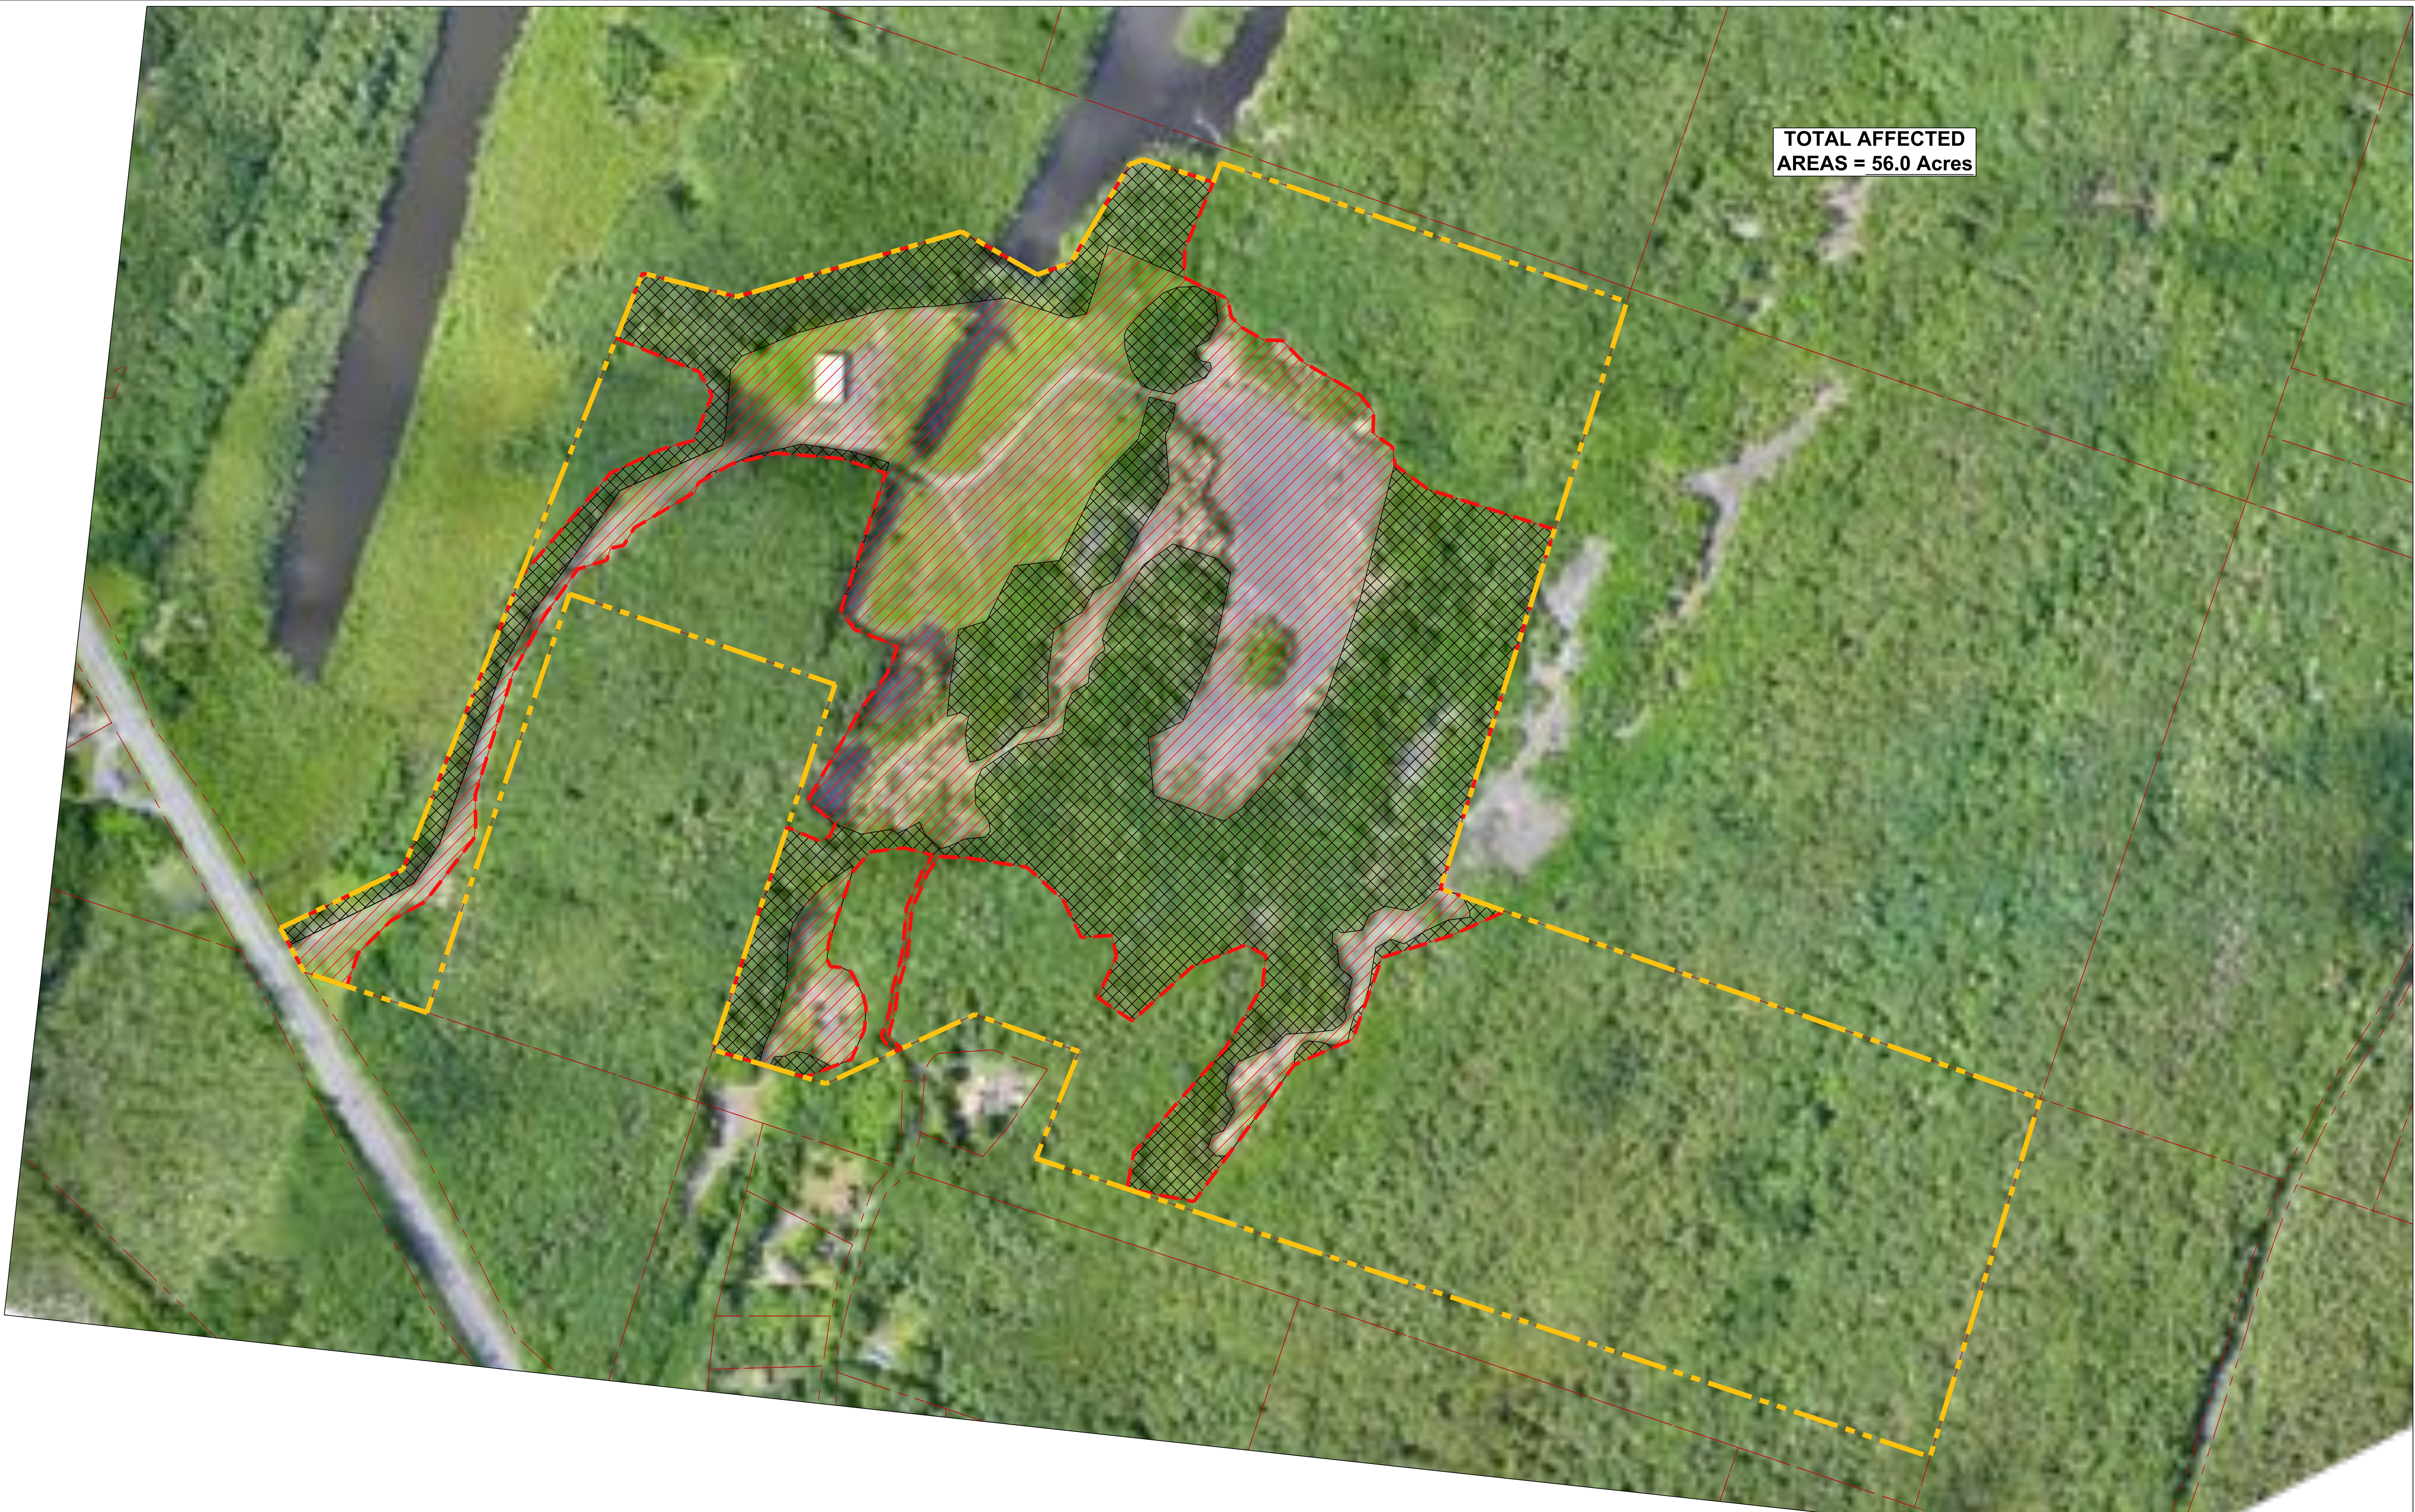
**FIGURE 1**  
SHEET 01 OF 01

The parcel consists of approximately 110 acres of cleared land, access roads, mine faces, mine spoil/tailing piles (bluestone and shale piles), wooded lands and surface water features. The Site is accessed via an approximately 20-foot wide gravel road along the western portion of the site. There is currently one 60-foot by 100-foot garage on site, with a cleared and level parking area graded around the building. The central portion of the Site is a recently affected bluestone mining area consisting of processing areas, old structural footings, vertical mine faces, mine floor and spoil piles of bluestone (Figure 1).

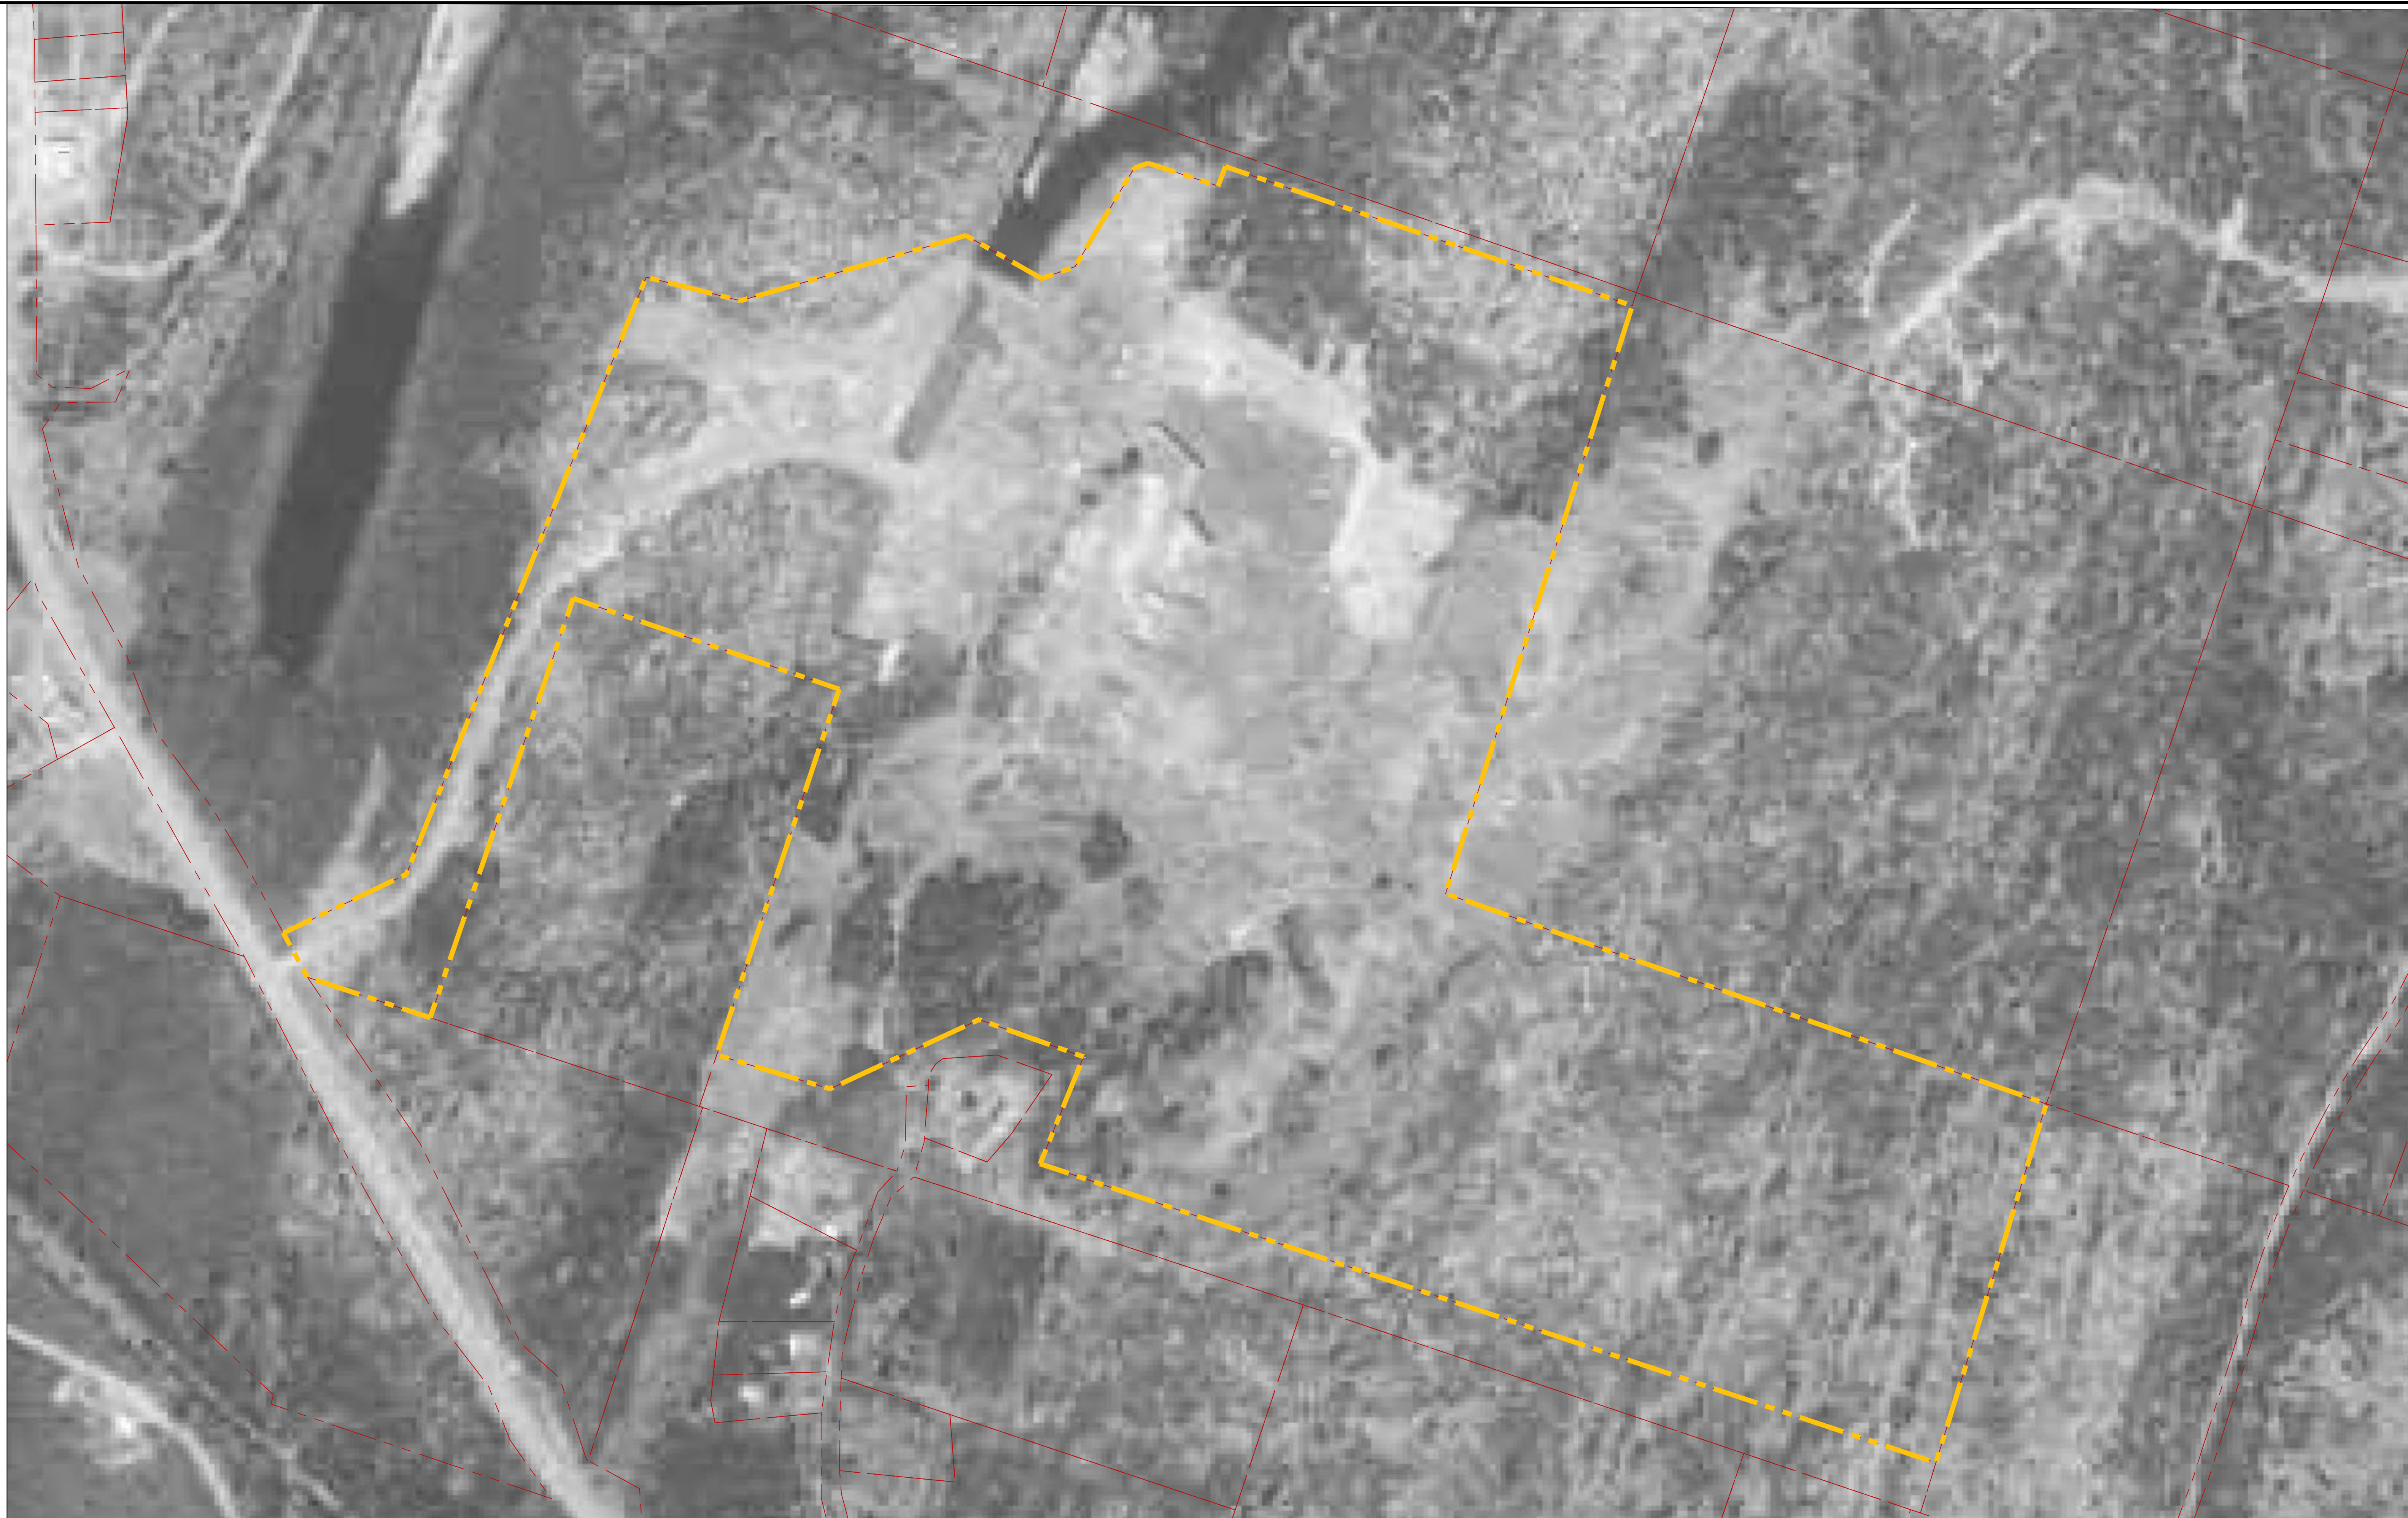
**FIGURE 3**  
 SHEET 01 OF 01

Figure 3 is an aerial photo of the Site and surrounding area from 1978. It clearly shows that most of the vegetation has been cleared from the Site and the mine faces and mine floor throughout much of the property. Note also that there are no water features located on the Site at this time with the exception of the surface water feature along the northern end of the property. Figure 4 is an aerial photo of the Site from 1986; the photo shows the Site being actively mined for bluestone, stockpile areas and now the presence of the water surface features on the western side of the mining area. In addition, Figure 5, 1997 USGS Topographic Map of Site, shows the proposed affected area as being a Disturbed Surface.
