**Subject: Wetland Mapping and Affected Area-Habitat Assessment  
850 Rte. 28 Site  
Town of Kingston, NY**

## 850 Route 28 Property Wetland Narrative

## 850 Route 28 Property Disturbed Area Assessment

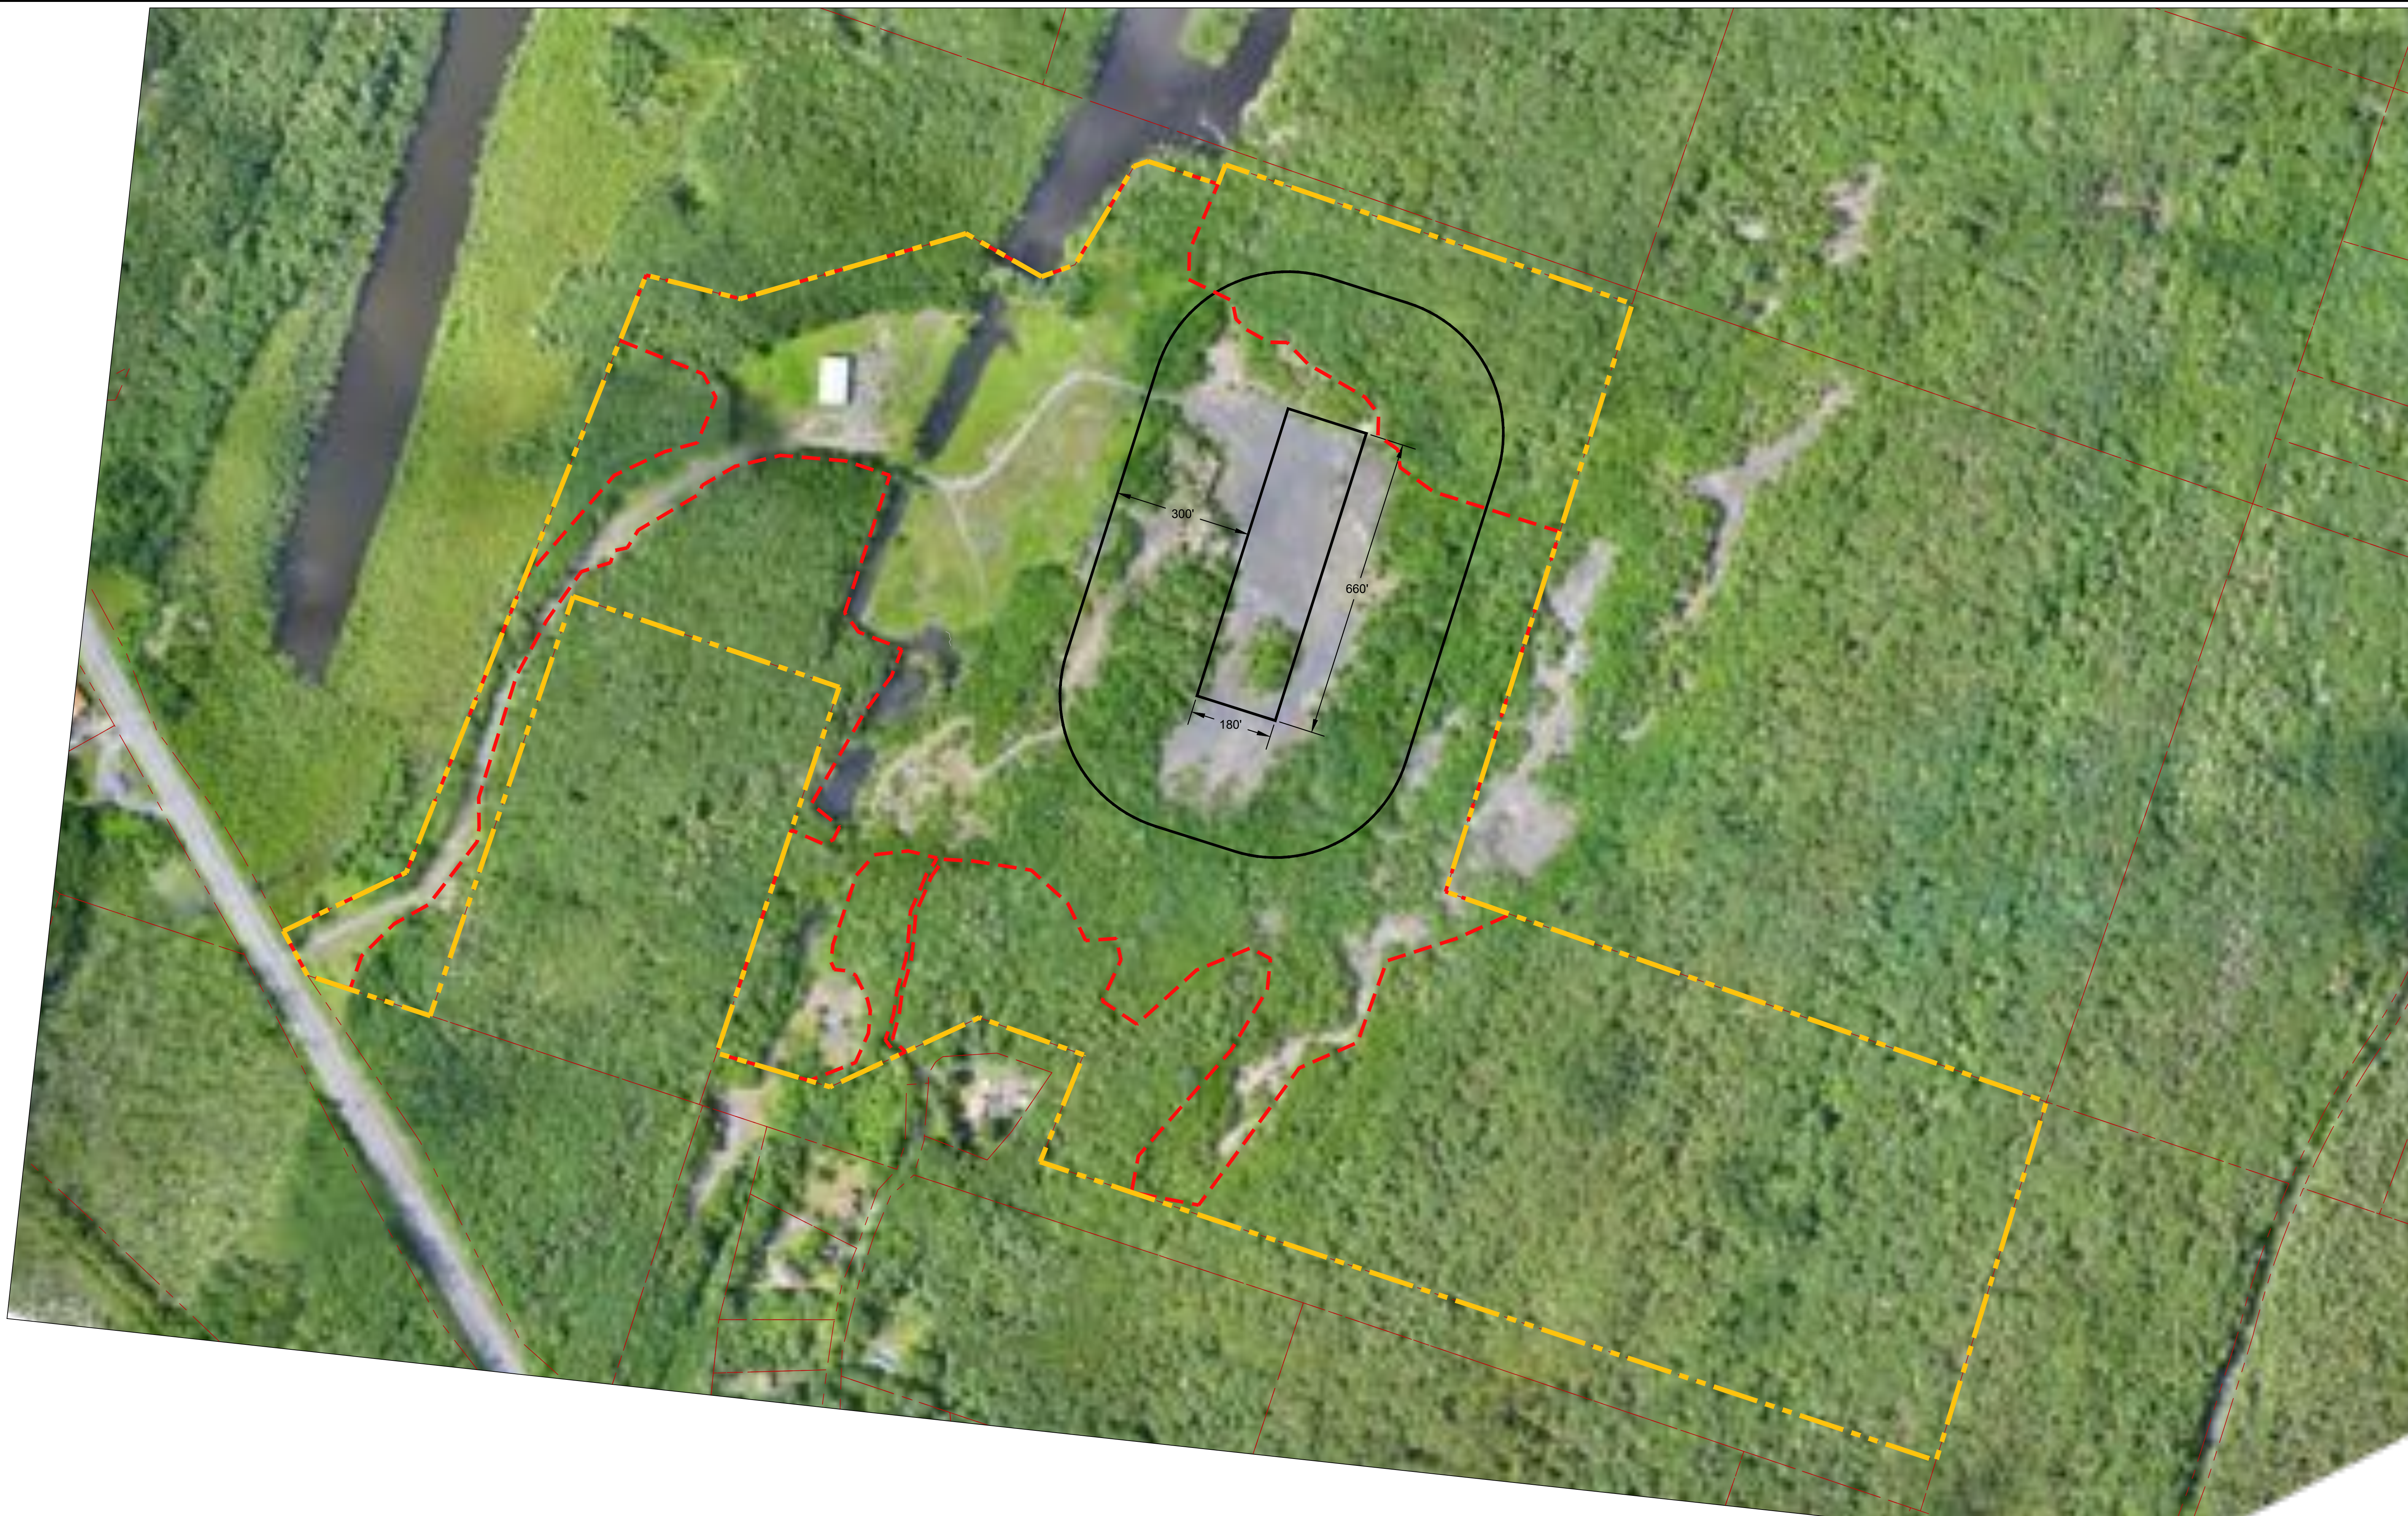
**FIGURE 6**

In summary, a review of historic aerial mapping and USGS quadrangle sheets confirm that 60 acres or 60% of the Site has been significantly disturbed by mining excavation, spoil piles and clearing activities (Figure 6). The tree growth across most of the site is younger than 20 years old confirms the date to which most of revegetated portions of the Site has been affected. The historical mapping of the Site indicates that mining activities have occurred on the Site more or less continuously since the early 1970s with modern equipment. It is likely that portions of the Site beyond those observed in the field and on aerial imagery had been mined with early mining techniques for the extraction of bluestone as was common throughout this portion of the Catskill Mountain region.
