**Subject: Wetland Mapping and Affected Area-Habitat Assessment  
850 Rte. 28 Site  
Town of Kingston, NY**

## 850 Route 28 Property Wetland Narrative

## 850 Route 28 Property Disturbed Area Assessment

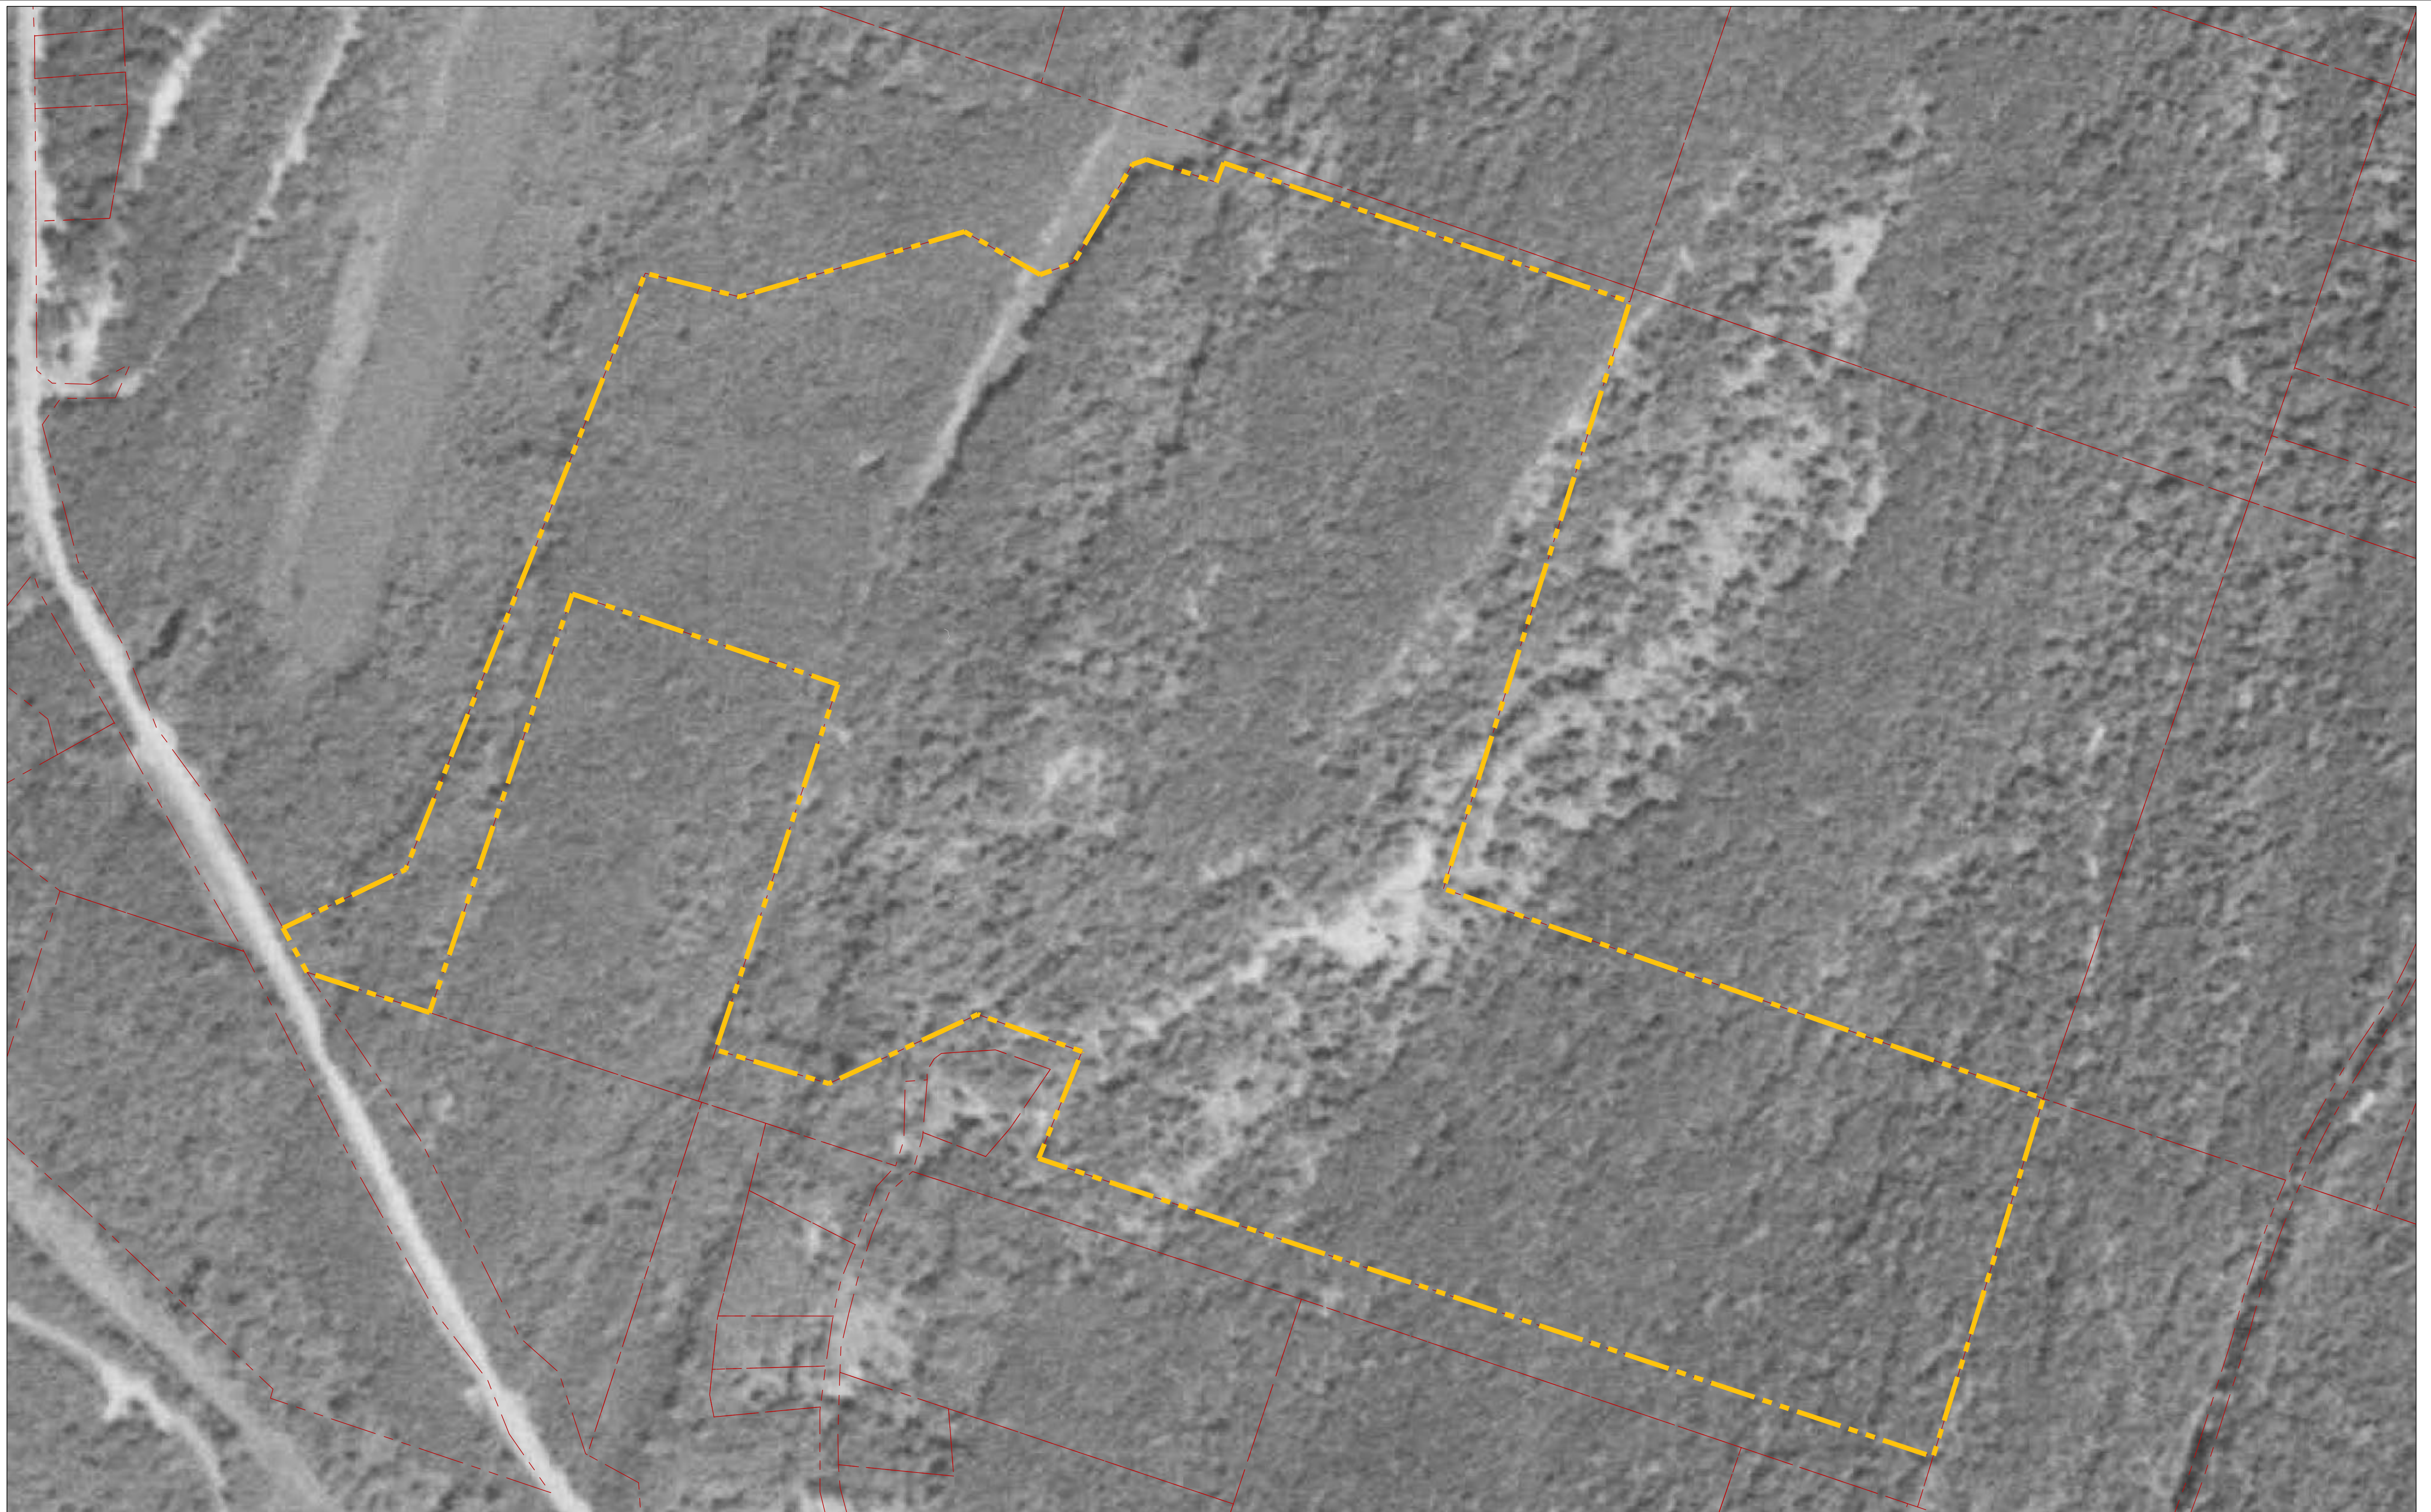
**FIGURE 1**  
SHEET 01 OF 01

The parcel consists of approximately 110 acres of cleared land, access roads, mine faces, mine spoil/tailing piles (bluestone and shale piles), wooded lands and surface water features. The Site is accessed via an approximately 20-foot wide gravel road along the western portion of the site. There is currently one 60-foot by 100-foot garage on site, with a cleared and level parking area graded around the building. The central portion of the Site is a recently affected bluestone mining area consisting of processing areas, old structural footings, vertical mine faces, mine floor and spoil piles of bluestone (Figure 1).

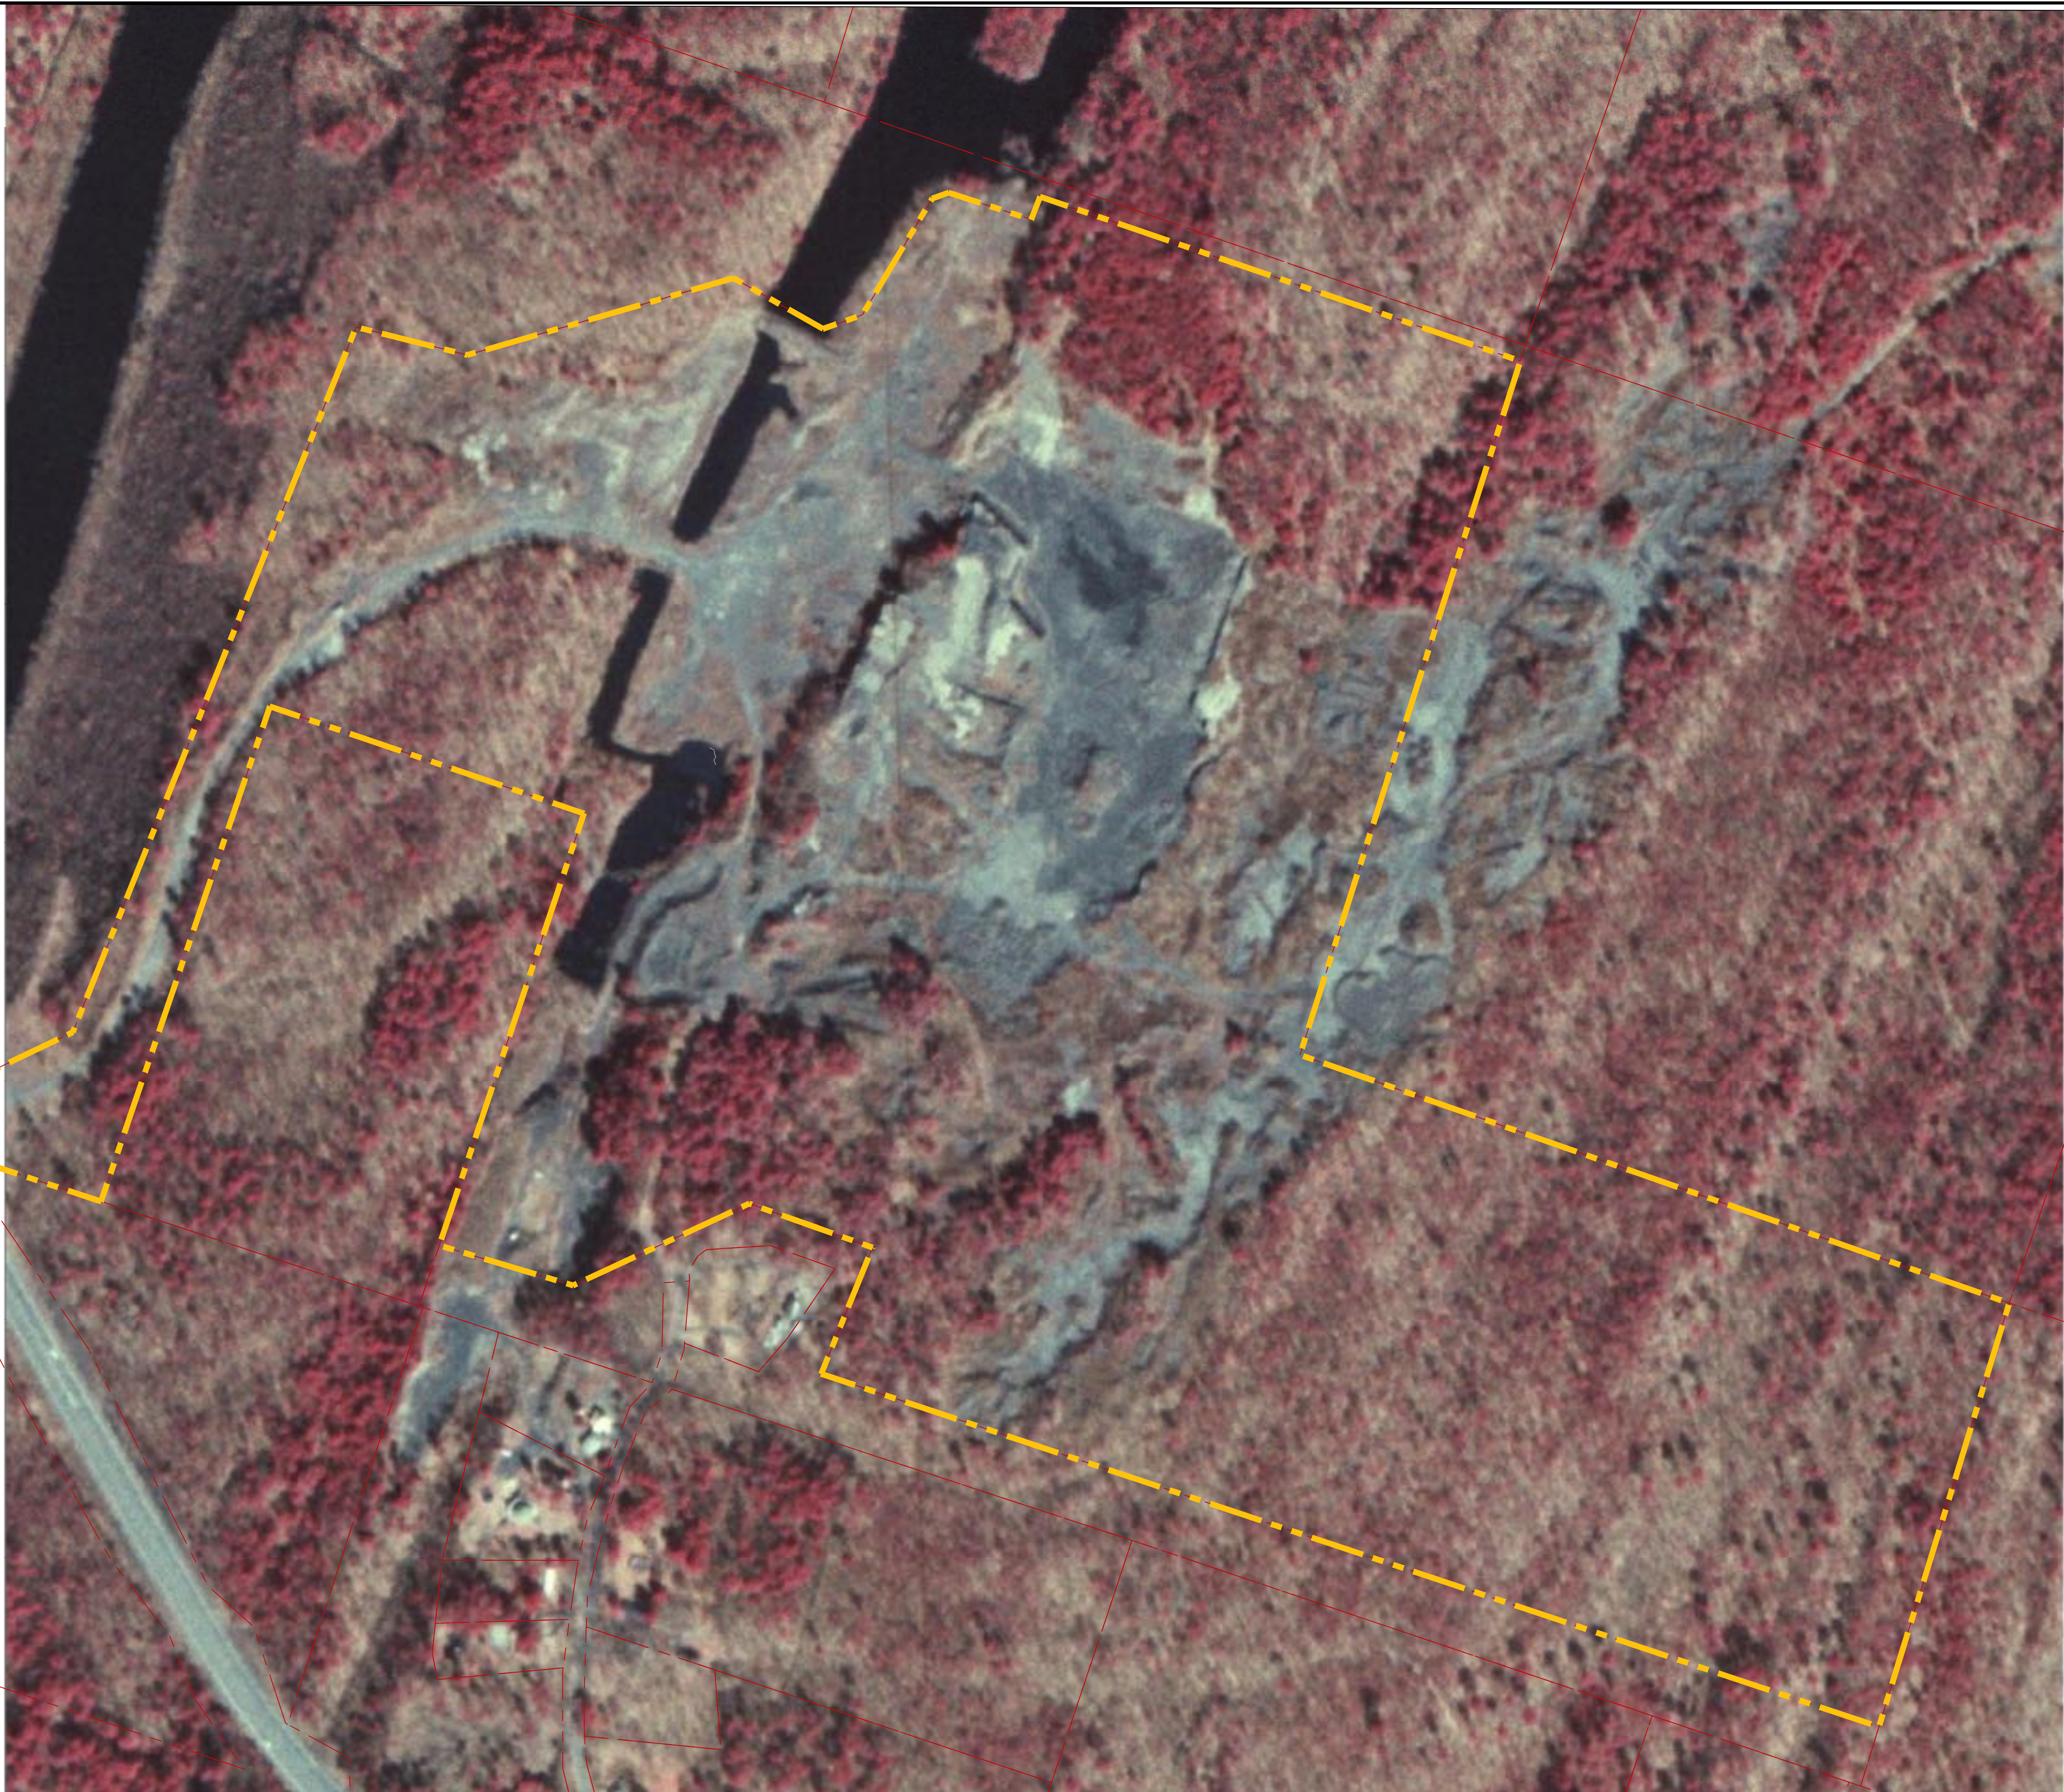
**FIGURE 3**  
 SHEET 01 OF 01

Figure 3 is an aerial photo of the Site and surrounding area from 1978. It clearly shows that most of the vegetation has been cleared from the Site and the mine faces and mine floor throughout much of the property. Note also that there are no water features located on the Site at this time with the exception of the surface water feature along the northern end of the property. Figure 4 is an aerial photo of the Site from 1986; the photo shows the Site being actively mined for bluestone, stockpile areas and now the presence of the water surface features on the western side of the mining area. In addition, Figure 5, 1997 USGS Topographic Map of Site, shows the proposed affected area as being a Disturbed Surface.
