RE: **Response to Steve Malloy Comments On 850 Route 28 LLC Project Dated 04/15/2019**

Noise Study Dated February 2019

ROUTE 28 NOISE STUDY
850 ROUTE 28, LLC.

WEST HURLEY, ULSTER COUNTY, NY

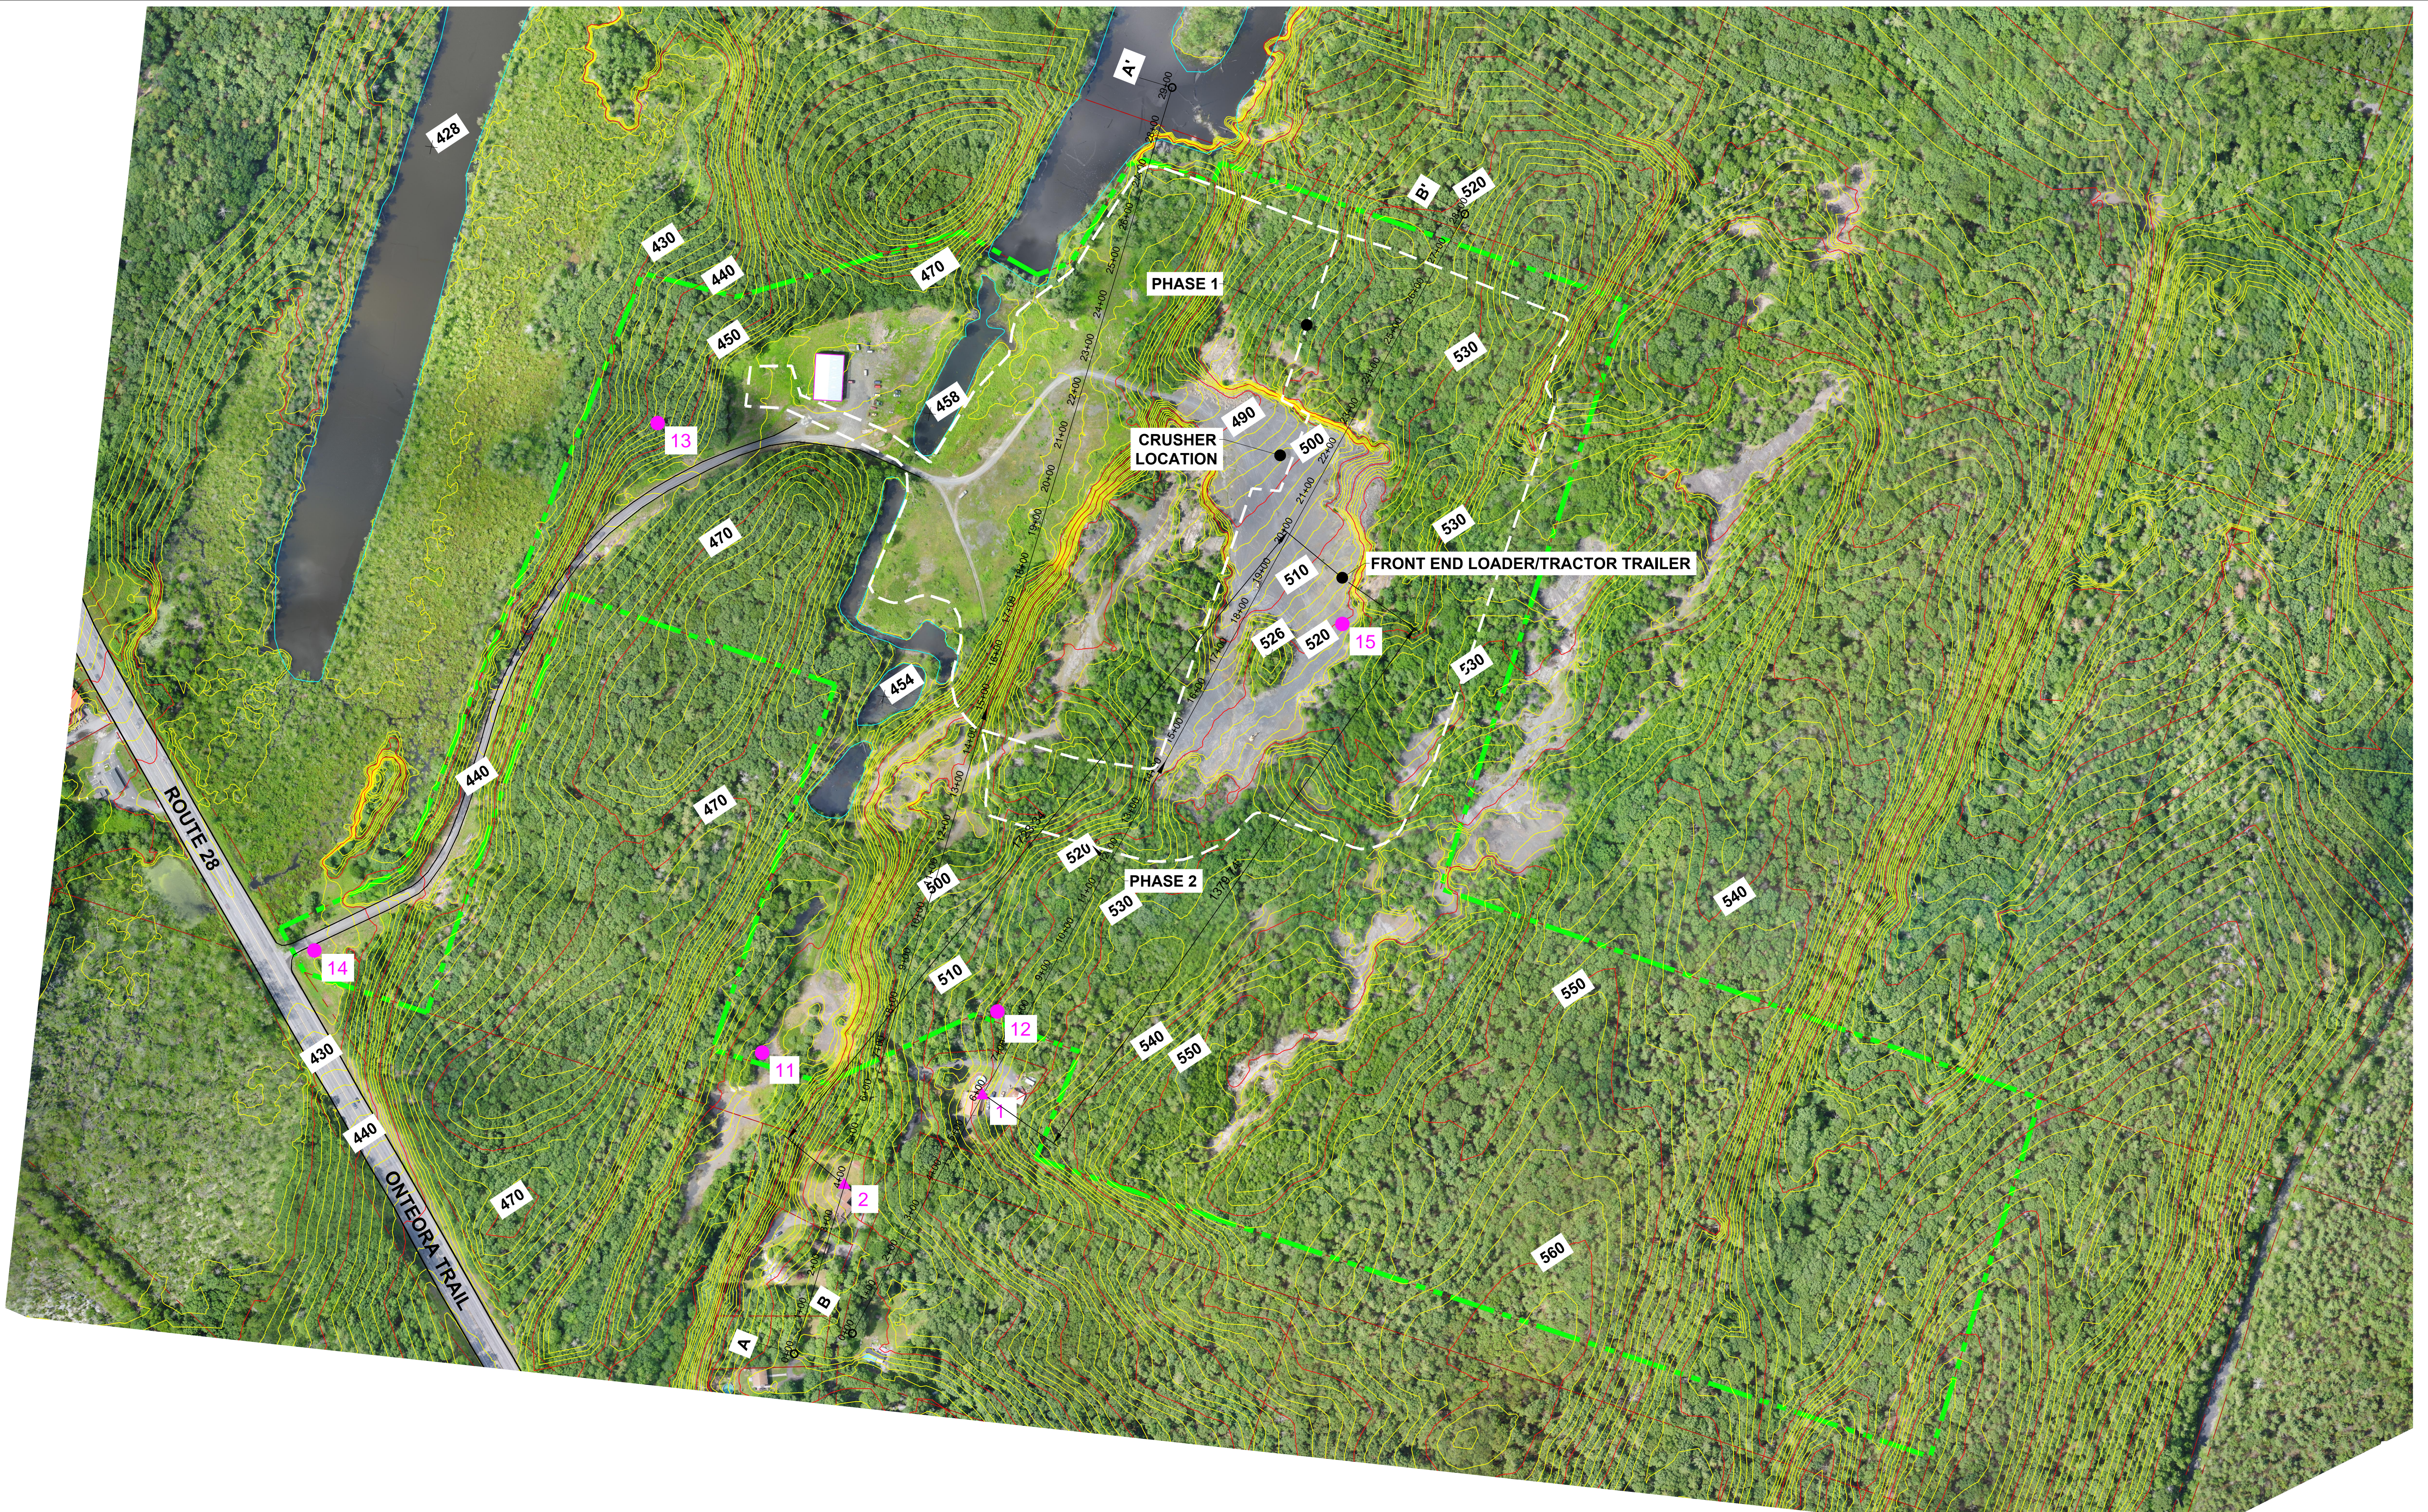
FIGURE 2
 SHEET 01 OF 02

A revised Figure 2 is attached showing the location of the front end loader loading shot rock into a tractor trailer, and the distances to each residence.

- 4. The report does not note where the front end loader loading into the tractor trailer was in relation to the logging stations. That should be noted on the drawing showing distances to residence.**
